Architectural Inventory Form

1. Resource number: 5HN68.72
2. Temporary resource number: 23
3. County: Hinsdale
4. City: Lake City
5. Historic building name: *Edwards Residence*
6. Current building name: Edmondson House
7. Building address: 333 Bluff Street, Lake City, CO 81235
8. Owner name and address: Nelma Edmondson c/o Robert Edmondson, 1310 Hamilton , Pampa TX 79065

48. Report title: 2003 Architectural Survey of Lake City, Colorado

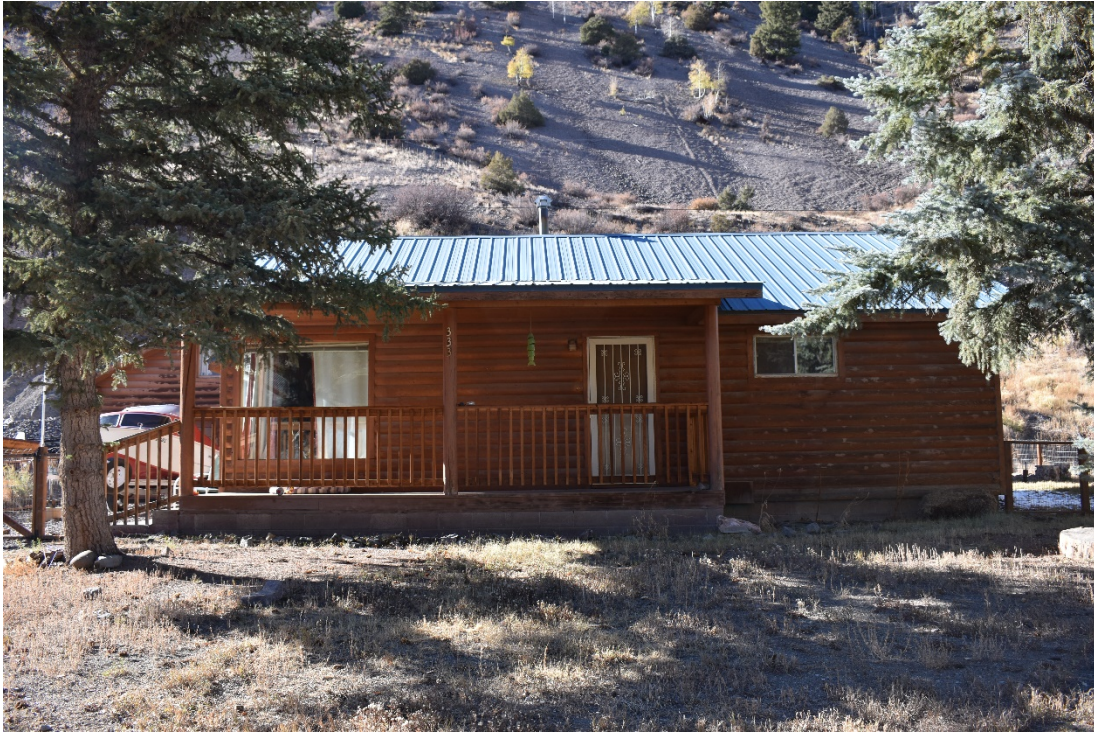
CD 1, Image 23, View to West, of the dwelling

14. Building plan: Rectangular
15. Dimensions: 864 square feet
16. Number of stories: 1
17. External wall material(s): Wood
18. Roof configuration: Side gabled
19. Roof material: Metal
20. Special features: Porch, ~~garage~~
21. General architectural description:
One-story, side-gabled frame dwelling with metal roof. Walls clad in manufactured log siding. Shed-roofed porch has round wooden posts; shelters off-center entrance with paneled door and security storm door. Second, shed-roofed entry porch on south elevation shelters a paneled door and security storm door. Concrete foundation.
22. Architectural style/Building type: No style
23. Landscaping or special setting:

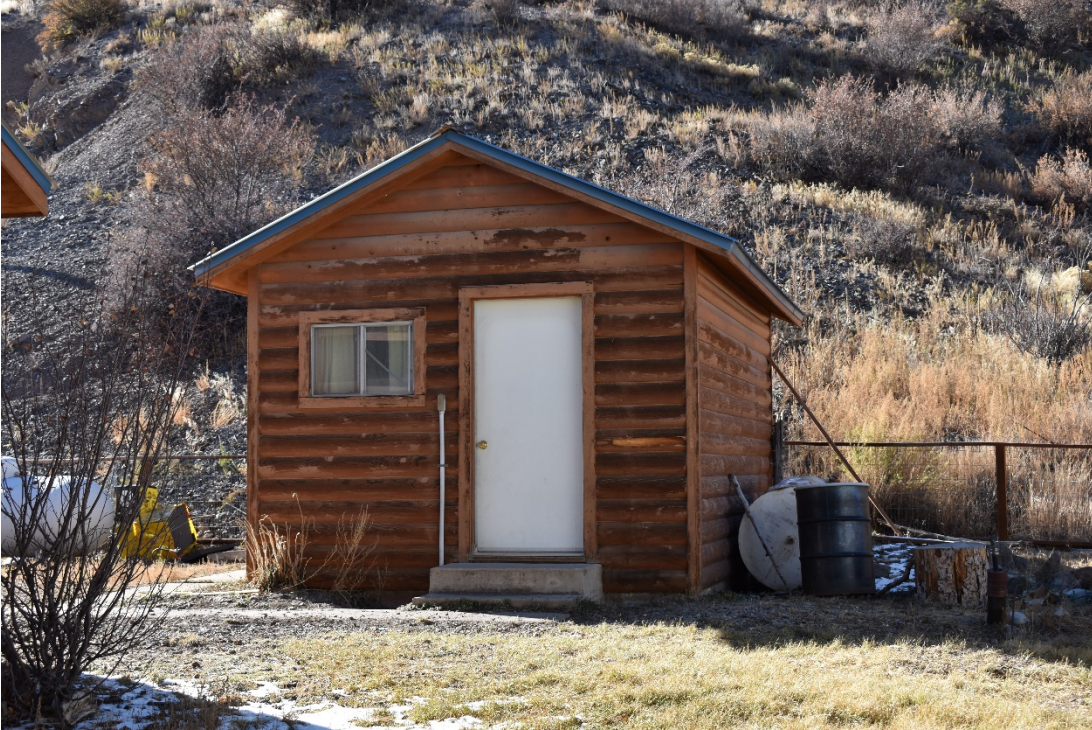
CD 1, Image 27, View to West, of the shed

One-story, front-gabled frame shed clad in manufactured log. Entrance in east elevation has solid door accessed by concrete block stoop and small metal-frame, slider window.

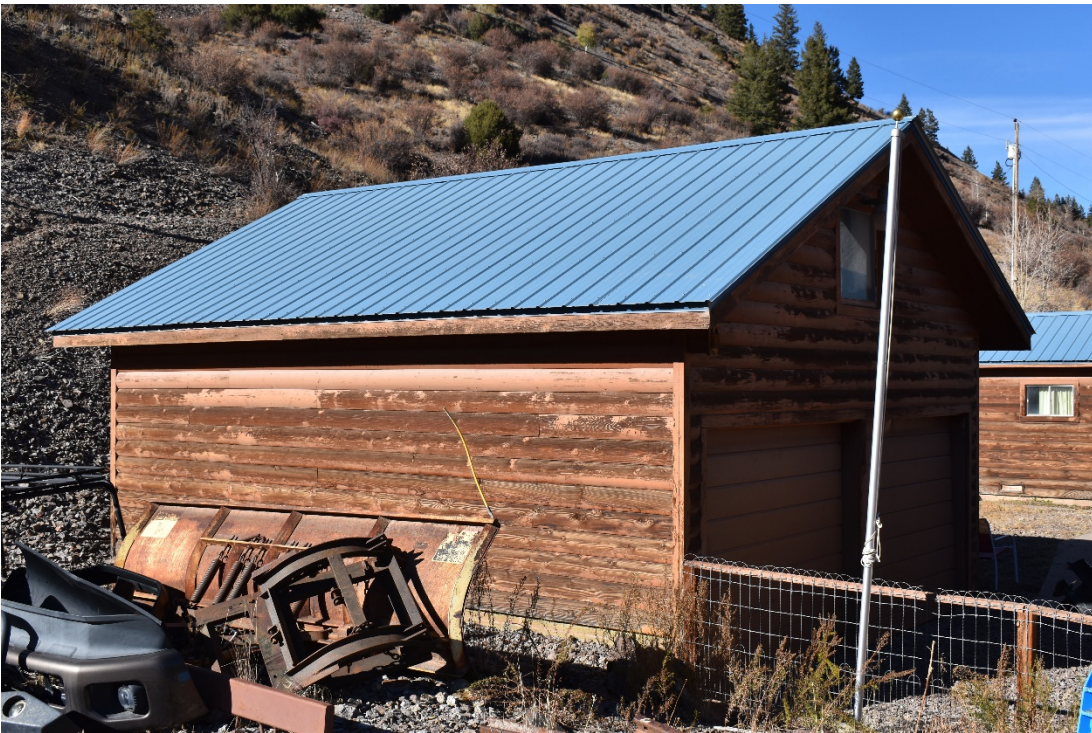
CD 1, Image 28, View to Northwest, of the Garage

Front-gabled, frame double car garage with steeply pitched, metal roof; walls clad in manufactured log. Small fixed-sash window in gable end.
