Architectural Inventory Form

1. Resource number: 5HN68.28
2. Temporary resource number: 10
3. County: Hinsdale
4. City: Lake City
5. Historic building name: Pitkin Guard Armory *Lake City Opera House ~ Lake City Town Office & Jail*
6. Current building name: Armory *Lake City Recreation Department*
7. Building address: 230 Bluff Street, Lake City, CO 81235
8. Owner name and address: Town of Lake City, 230 North Bluff Street, Lake City CO 81235

48. Report title: 2003 Architectural Survey of Lake City, Colorado

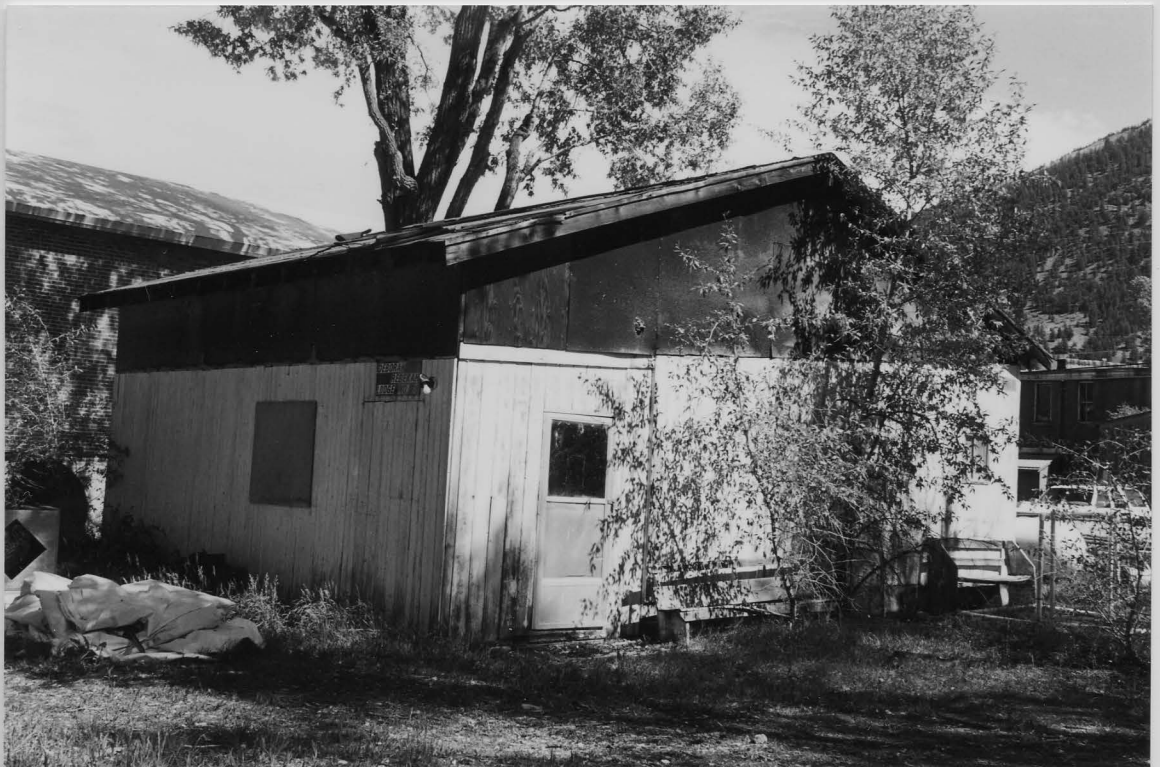
5HN. 68.28
Rebekah Hall 9/2002

Rebekah Hall, circa 1960

Side-gabled frame dwelling with composition roofing and walls clad in hardboard. The flat roof was raised with a front-gabled roof structure around 1980. Window openings are covered in plywood. Off-center entrance on south façade has a solid door and aluminum screen door. Concrete foundation
