Architectural Inventory Form

1. Resource number: 5HN68.106
2. Temporary resource number: 74
3. County: Hinsdale
4. City: Lake City
5. Historic building name: Silver Scene Photography
6. Current building name:
7. Building address: 322A Silver Street, Lake City, CO 81235
8. Owner name and address: Robert and Mary Stigall, P.O. Box 608 , Lake City CO 81235

47. Photograph numbers: Roll 11, frame 5A; Roll 15, frame 8A Negatives filed at: Lake City Town Hall
48. Report title: 2003 Architectural Survey of Lake City, Colorado
49. Date(s): September 2002 - June 2003
50. Recorders Cathleen M. Norman and Grant E. Houston
51. Organization: Town of Lake City
52. Address: 230 Bluff Street, Lake City CO 81235 53. Phone no. (970) 944-2333

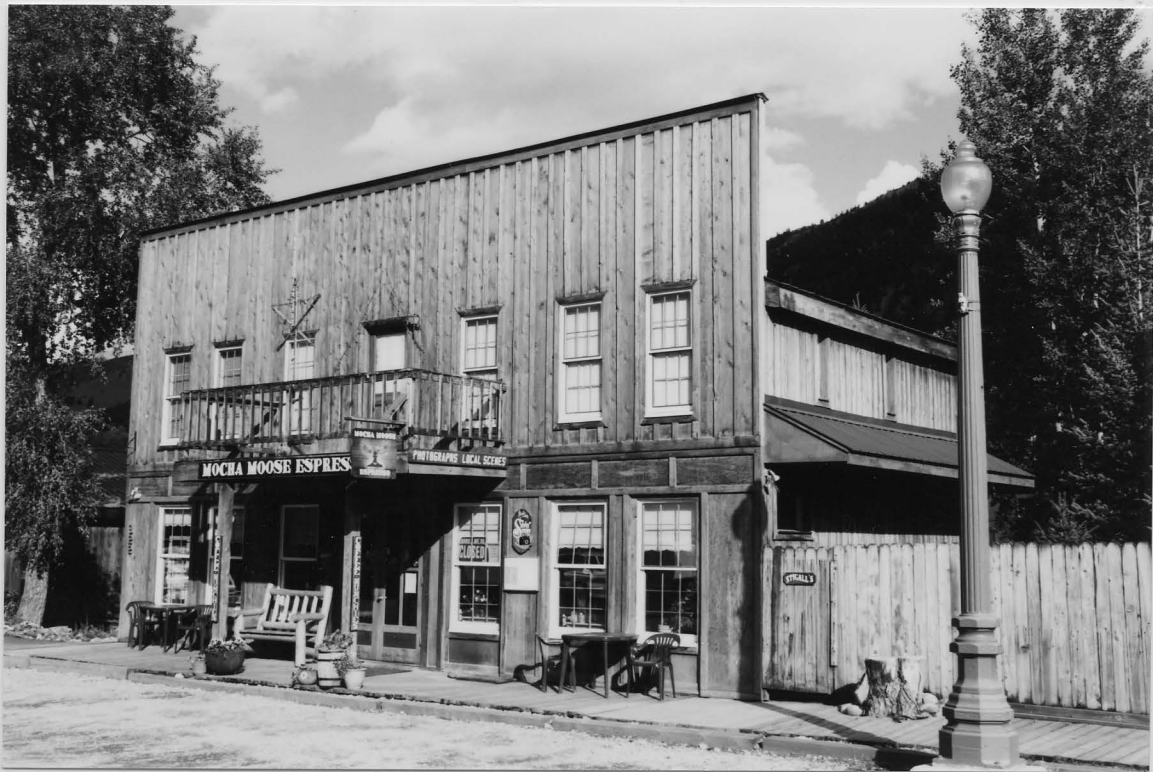
54N. 68.106
9/2002

19. Roof material: Metal
20. Special features: Balcony, porch
21. General architectural description:
1-1/2 story, front-gabled building with false-front facade. Metal roof. Side walls are clad in vertical wood siding. Façade is clad in board and batten. Upper story has series of 6-over-6 windows and a centered door that accesses a balcony porch. First floor façade has 9-over-9 windows on either side of a centered entrance with paired paneled and glazed doors. First-floor porch deck is boardwalk along Silver Street. Rear section consists of two facing shed-roofed sections. Door and small balcony in east elevation. Concrete foundation.
